# APPENDIX B

Infrastructure Asset  
Management Plan

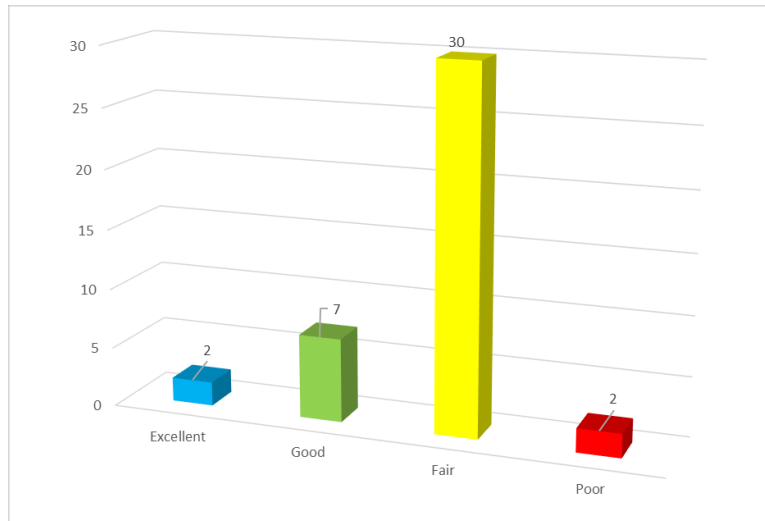
**Figure B-4: Educational sector buildings condition assessment**

Figure B-4, is a snapshot of the school buildings condition assessment. Two of the existing buildings in the Nauru Primary School are in poor condition. Both buildings are pre-fabricated structures, as shown in Figure B-5, transferred from the old Regional Processing Centre. The sub-floor has degraded prematurely due to water damage. The buildings were originally air-conditioned. These air-conditioners were installed on concrete pillars and the sub-floor was exposed to moisture from condensation, which resulted in premature degradation. These buildings have low ceilings that are not suitable for ceiling fans.

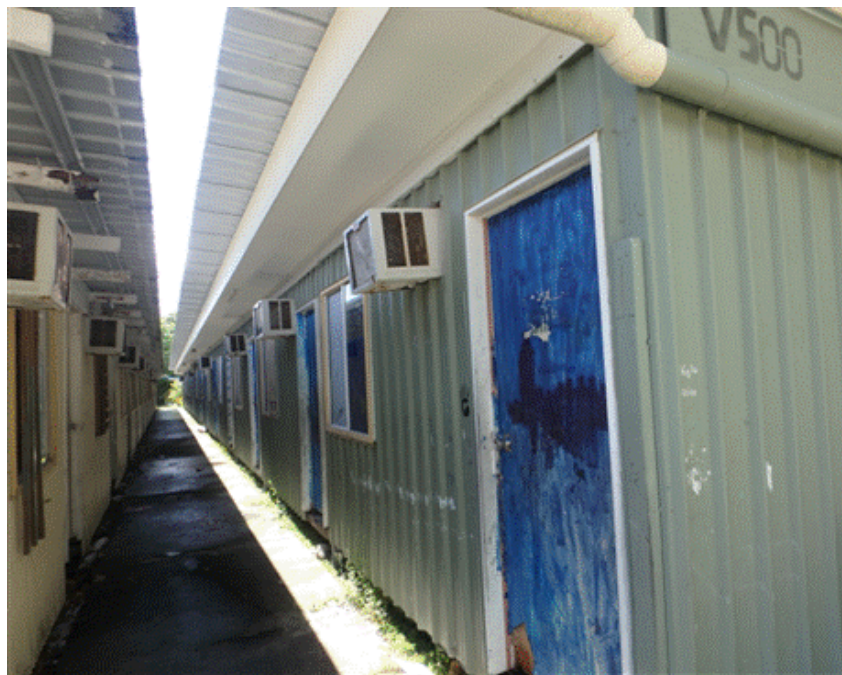
**Figure B-5: Pre-fab buildings at Nauru Primary School in poor condition**

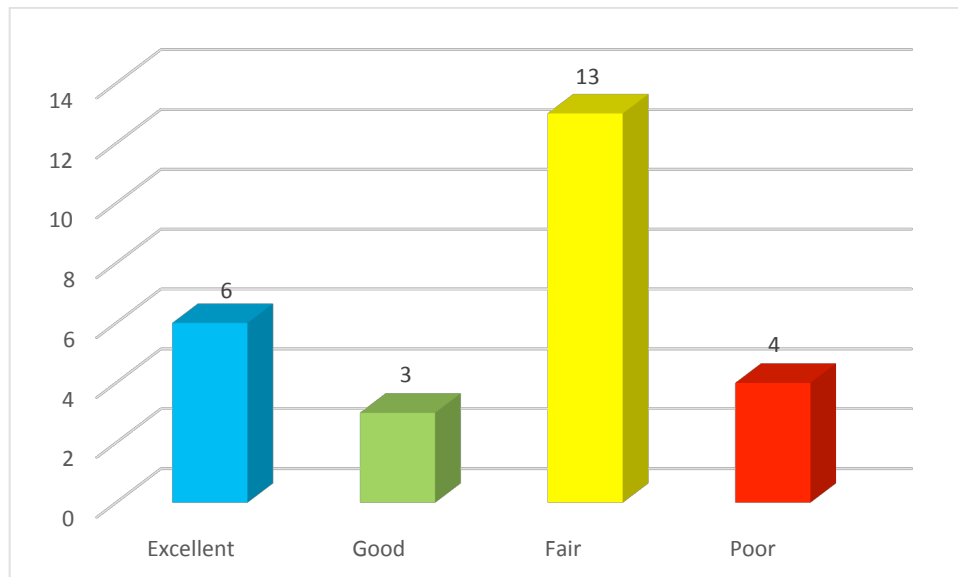
**Figure B-6: Civic, administration and emergency services buildings**

This sector includes a total of 26 buildings and includes the main government administrative office, the parliament, the conference center, the sports complex, the police and ICT department buildings, the courts, and the jail buildings. As shown in Figure B-6, four of the buildings are in poor condition, including two very old buildings used as the jail, the land records committee building, and the radio broadcast and media center building. There is a new jail, which was constructed on top of the hill in 2016, but is vacant. It is recommended that the jail operations are moved to the new building. The media center building should be demolished and a new building should be constructed for media operations near the ICT office. The land records committee building in Uaboe district should be renovated, renewing the roof, fit-outs, flooring, and services.

The main administration building is in fair condition, but it needs major repairs and renovations to prevent further degradation, including repairs to exterior wall cladding and windows, the roof in several locations, renewal of air conditioning and plumbing fixtures and roof gutters. Similarly, there are four Ministry of Home Affairs buildings on Meneng Hill, all urgently requiring renovations to prevent further impairment, including roof renewal, exterior wall cladding, and renewal of mechanical and plumbing service fixtures.

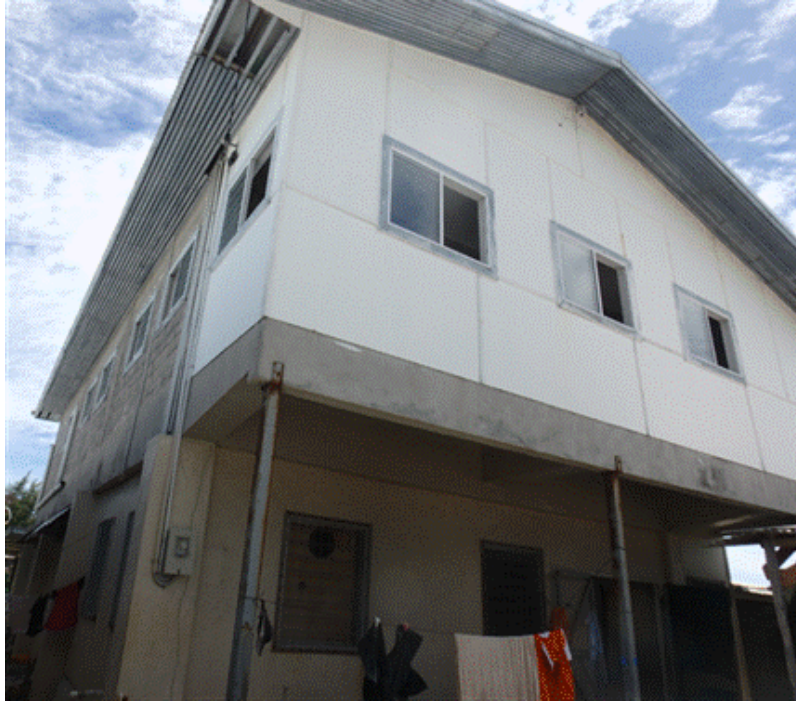
**Figure B-7: Jail building in poor condition**

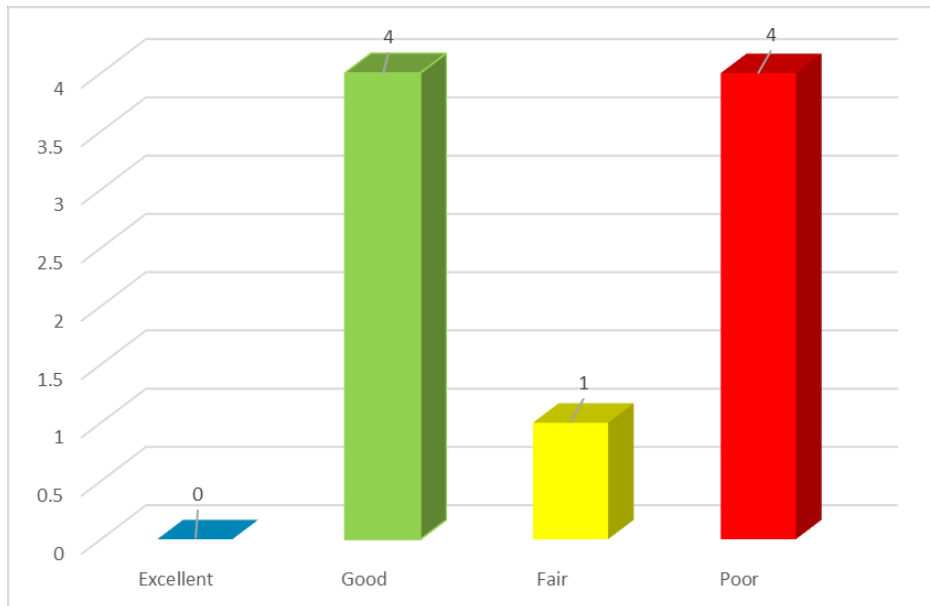
**Figure B-8: Health sector buildings**

Figure B-8 shows the condition assessment of the health sector buildings. Four of the existing buildings are in poor condition, including the old, unrenovated buildings at the hospital site, both existing buildings at public health building site in Denig and one of the abandoned clinic buildings, which appears to have been vandalised in Meneng district.

To improve the health sector infrastructure, the old hospital buildings should be renovated on an as-required basis following the original Master Plan for Stage-3 Redevelopment. There is an immediate need for a maternity ward and an isolation ward. At the public health building site, the masonry-walled building should be renovated, and the timber-framed building should be demolished. The capacity assessment identified the need for nursing residential quarters, which can be constructed at the site vacated by demolition of the timber-framed building at the public health site. The clinic in Meneng requires a new roof and new windows.

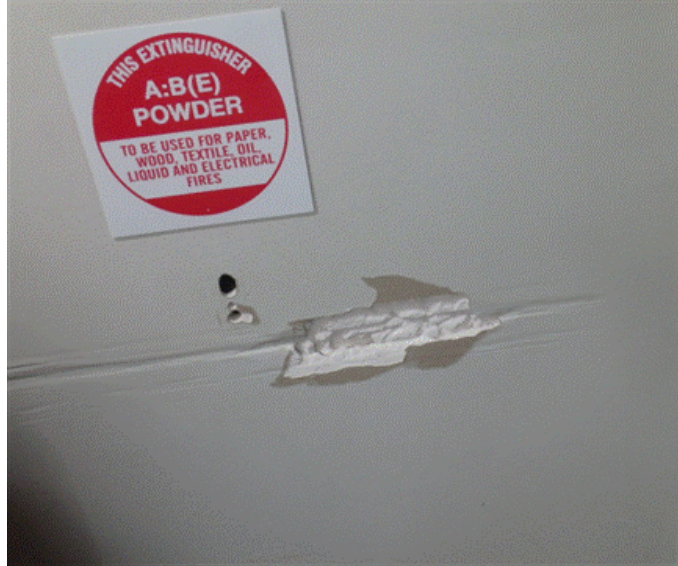
During the inspection of the health sector buildings, the poor quality of construction and use of inappropriate materials for the local environment was noted. The following defects were noted in the newly constructed hospital complex building:

- Early corrosion and a high corrosion rate on a large number of steel members.
- The railings and hardware attached to the walls with screws are falling off in several locations, inside the building. It appears in a number of locations, the hardware was attached to the wall covering without any structural support.
- Some of the doorframes have warped, which appears to be related to the sagging of the subfloor.
- In many locations, the vinyl floor tiles are lifting off the subfloor.
- The selected wall materials do not appear to be fireproof.

**Figure B-9: Poor quality of construction at the new hospital building, showing where the fire extinguisher fell off its mounting**

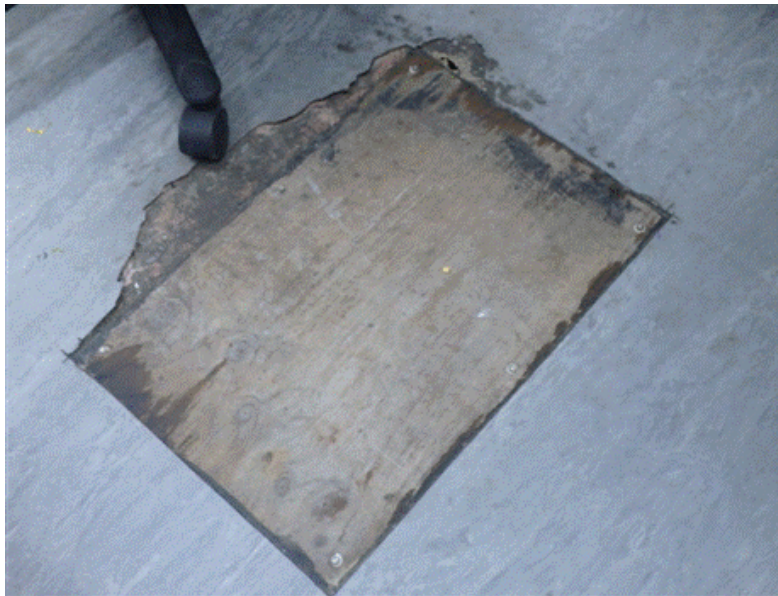
**Figure B-10: Poor quality of construction at the new hospital building where floor tiles are lifting off**

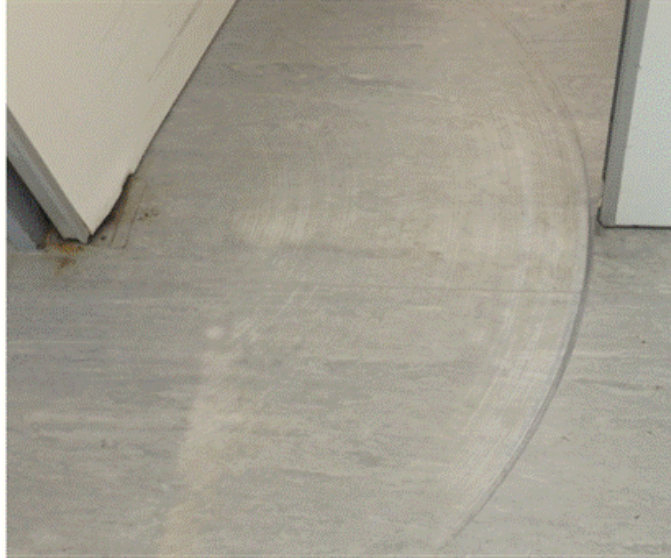
**Figure B-11: Poor quality of construction at new hospital building where door frames are warping**

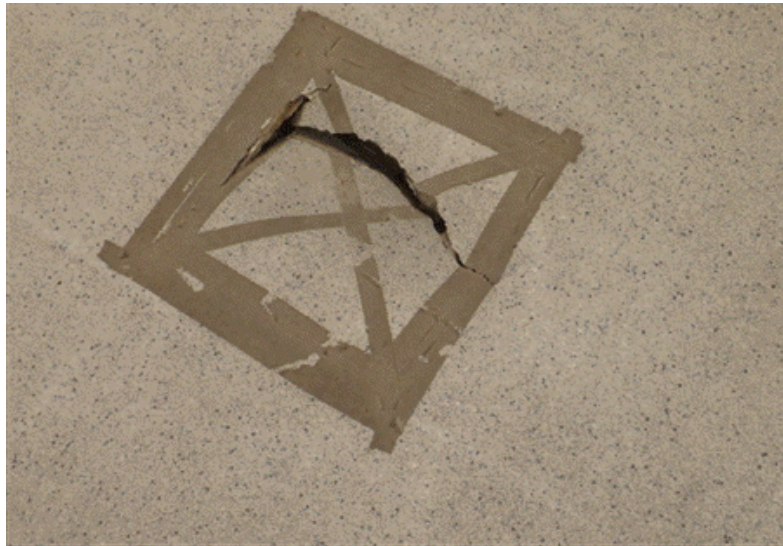
**Figure B-12: Poor quality of construction at the new hospital building where low ceilings and flimsy ceiling material is resulting in damage to ceilings**

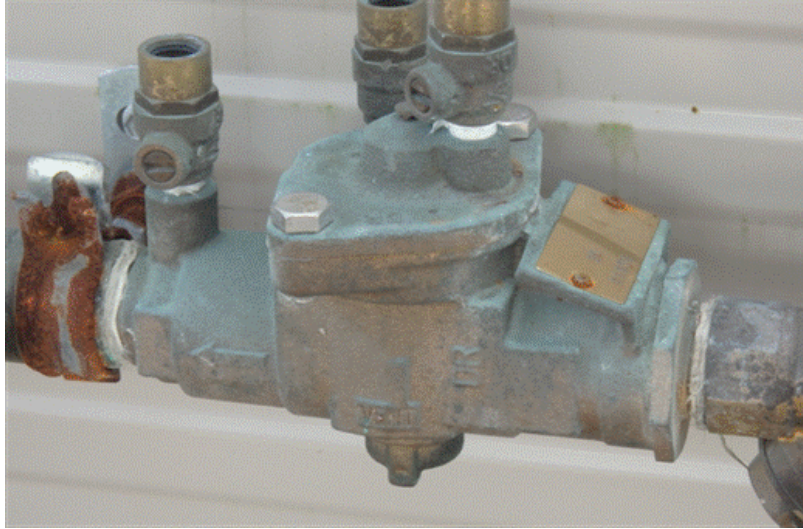
**Figure B-13: Poor quality of construction at the new hospital building where hardware is rusting**

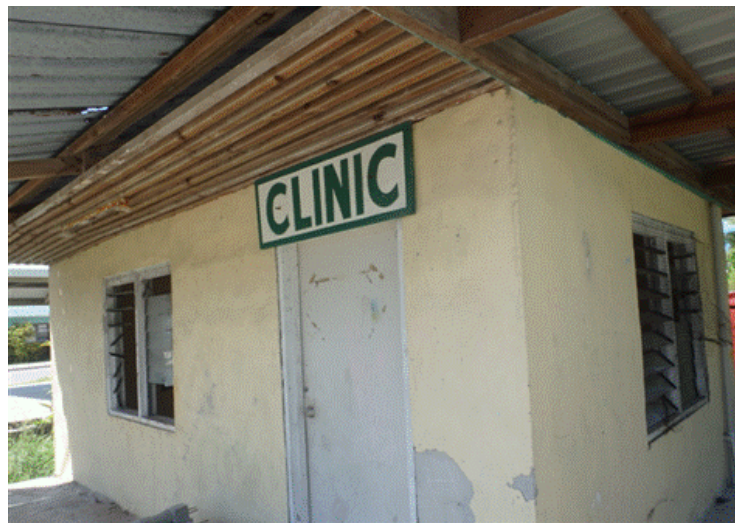
Similarly, the recently constructed clinic building in Meneng district is degrading due to poor quality construction and materials.

**Figure B-14: Recently constructed clinic building in Meneng—roof and windows are at the end of life**

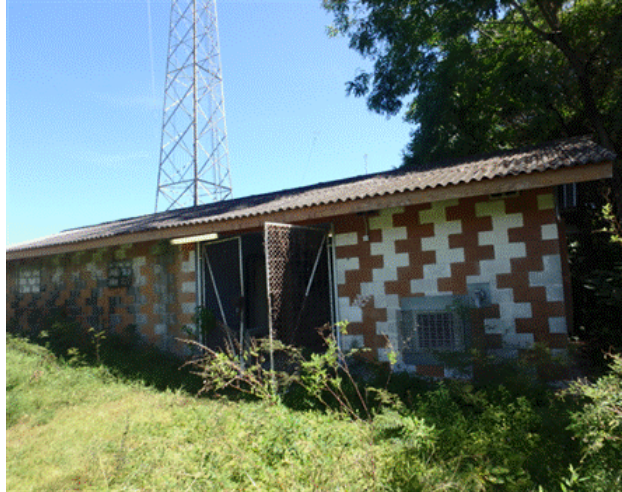
Four buildings service the aviation sector, including the airport building, the VIP lounge adjacent to the airport, and two small nav-aid equipment buildings on the hill. With the exception of the old masonry nav-aid equipment building (Figure B-15), which requires a new roof, ceiling, and repairs to the standby generator, the rest of the buildings are in good condition.

**Figure B-15: Aviation equipment shed needs new roof and renovation**

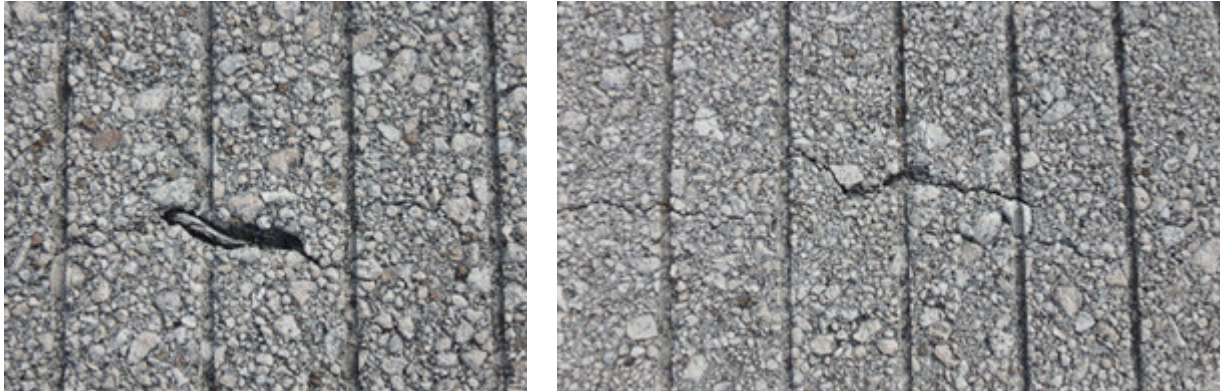
A visual inspection of the air strip revealed signs of surface degradation in the form of cracks in the surface layer and damage to the ridges in grooved section of the runway (Figure B-16). The pavement was inspected by subject matter experts from Fulton Hogan (New Zealand) in 2016 and based on the condition of the surface pavement, it was recommended that the surface pavement is resealed. While the sub-base of the air strip is in excellent condition, the surface

pavement is approaching the end of its service life and will need to be resealed within the next five years.

**Figure B-16: Typical surface defects in the runway**

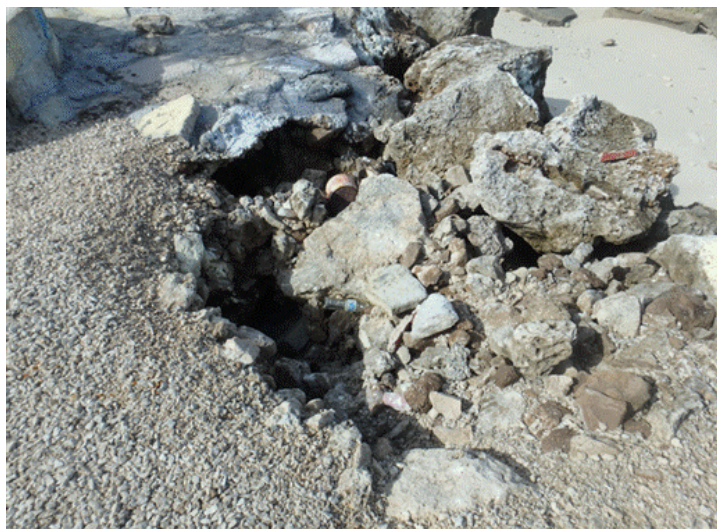
The rip rap in Meneng district (near the Yaren boundary) and the rip rap in the Yaren district (behind Nauru Secondary School) as shown in Figure B-17 are in poor condition. These rip raps have experienced repeated over-topping by waves, resulting in soil erosion under the rip rap, with the rocks falling off the top. These rip raps require capital repairs to prevent further degradation.

**Figure B-17: Rip raps in poor condition**

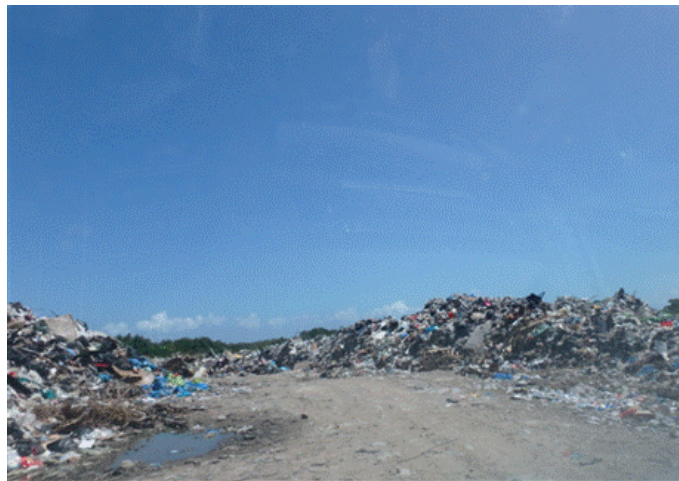
The existing landfill site in Nauru is considered in poor condition. Solid waste is dumped on the land surface without compaction and without the fill layers being covered by soil in between.

The landfill site does not have the provision for collection of leachate as shown in Figure B-18 and vent pipes are used to dissipate odor. These deficiencies may create environmental issues if leachate overflows and contaminates the surrounding ground. This is a serious concern because the landfill site is located close to the Buada district pond, which is the main pond to capture and store groundwater in Nauru.

**Figure B-18: Existing landfill site in Nauru**

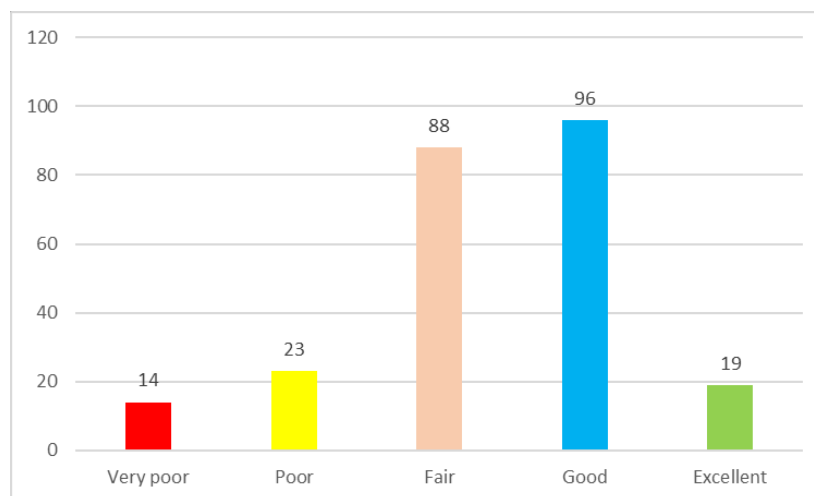
Figure B-19: Condition of light-duty motor vehicles

All light duty vehicles in Nauru, except those owned by NUC and NRC, are managed by the Public Service Administration. There are a total of about 240 vehicles in this pool. Figure B-19 summarizes the condition of light-duty vehicles as at May 2019. Vehicles in very poor condition require immediate replacement and vehicles in poor condition requiring replacement within two to five years.

Because the typical useful life of a light-duty vehicle in Nauru is 12 years, it is expected that all of the vehicles currently in fair condition will be in poor condition within the next 10 years.

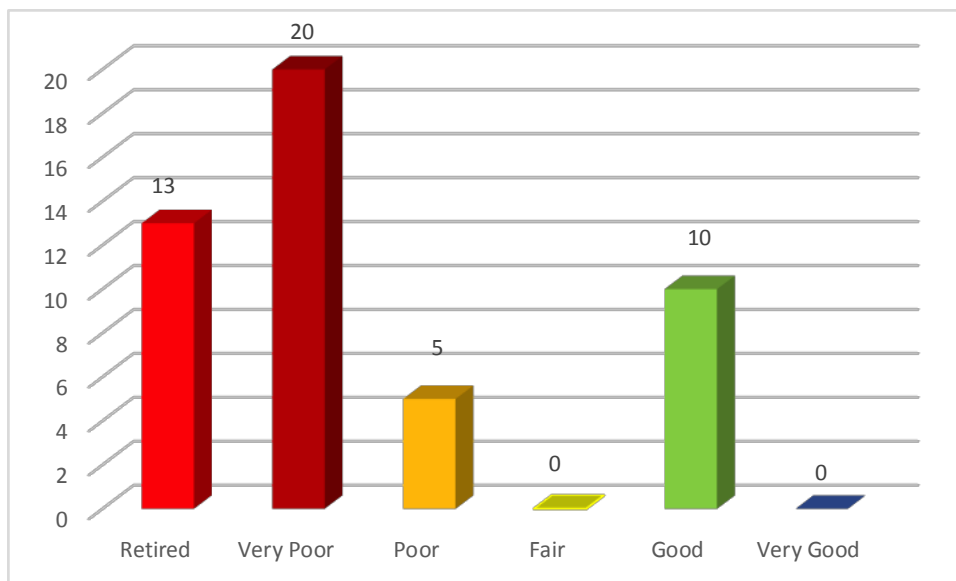
**Figure B-20: Condition of NRC heavy-duty vehicles**

Figure B-20 summarizes the results of condition assessment of heavy-duty motor vehicles managed by NRC. Lack of vehicles in fair or good operating condition is hampering the ability of NRC to carry out its intended functions.

All assets in poor and very poor condition will need to be replaced within the next two years and the remaining assets will need to be replaced at least once during the 10-year investment plan.
