Group 1 Exercise (Feb 17)

Electricity Utilities

Asset Condition Assessment For Power Lines

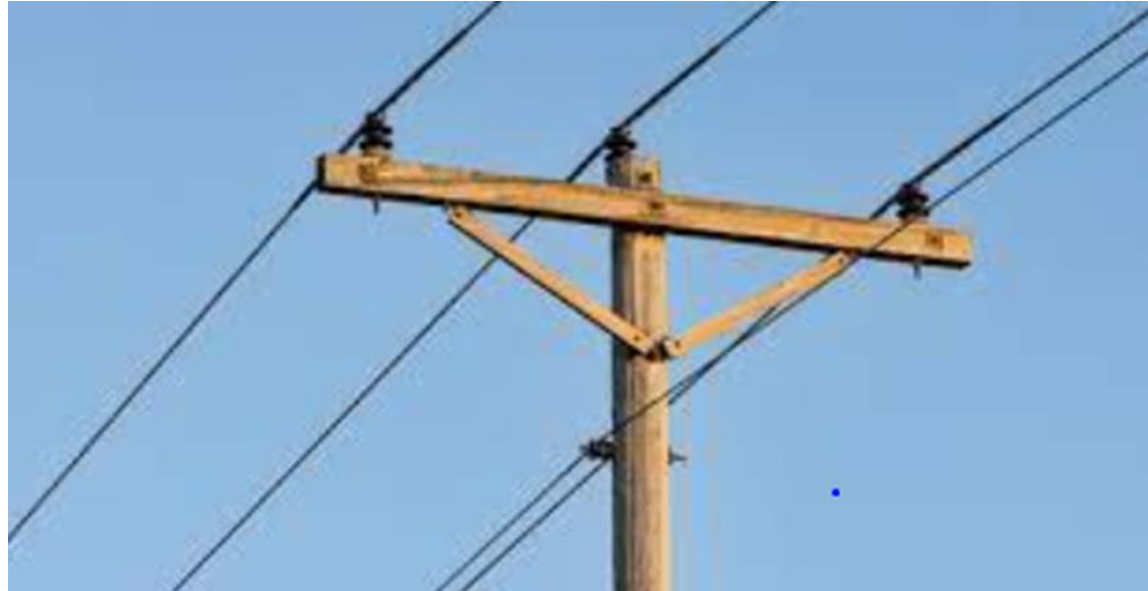
- Condition Assessment of a 10 km long, 3-ph, 11 kV, single circuit distribution line with 120 sq. mm AAC conductor, in Palau revealed the entire line section looks as shown in the photograph below. The wood poles and cross-arms are badly decayed but the conductors and insulators are in fair condition.
- The line experiences frequent breakdowns and reliability has been dropping over past 5 years.
- Calculate the asset condition index and formulate investment plan.

- Condition Assessment of a 10 km long, 3-ph, 11 kV, single circuit distribution line with 120 sq. mm AAC conductor, in Palau revealed the entire line section looks as shown in the photograph below. The wood poles and cross-arms are badly decayed, but the conductors and insulators are in fair condition.
- The line experiences frequent breakdowns and reliability has been dropping over past 5 years.

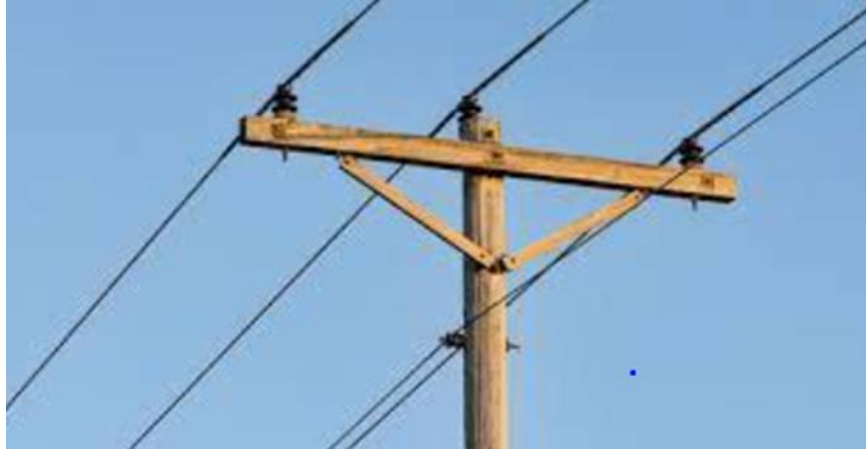
Based on the given information in second slide,

- Which rating would you give to the poles and crossarms?
- Please discuss within your group and assign a rating.

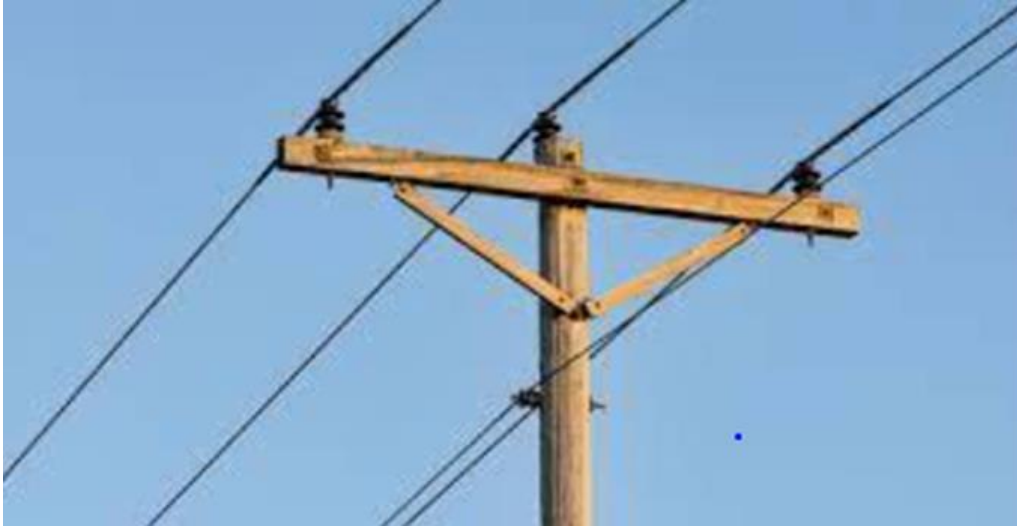
Based on the given information in the second slide,

- Which rating would you give to the insulators and conductors? Please read the given information about insulators and conductors
- Please discuss within your group and assign a rating.

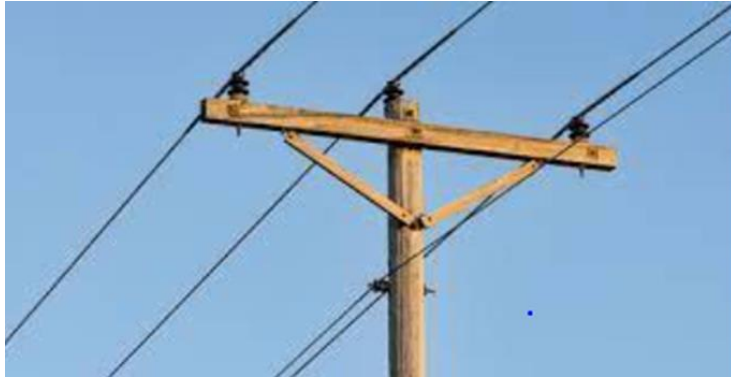
Condition Assessment of Distribution Line

Physical Condition Ratings	
Poles and cross arms	2
Conductors and Insulators	3
Functional Performance Rating	2
Asset Condition Index	46
Remaining Useful Life	20% to 50%
Risk of Failure	moderate
Estimated Investment	780K
